DEVELOPMENT OF A RAPID CURRENT CONTAINMENT BOOM:

PHASE III, YEAR 2

TECHNICAL REPORT

Jere Chase Ocean Engineering Center
University of New Hampshire
Durham, NH 03824

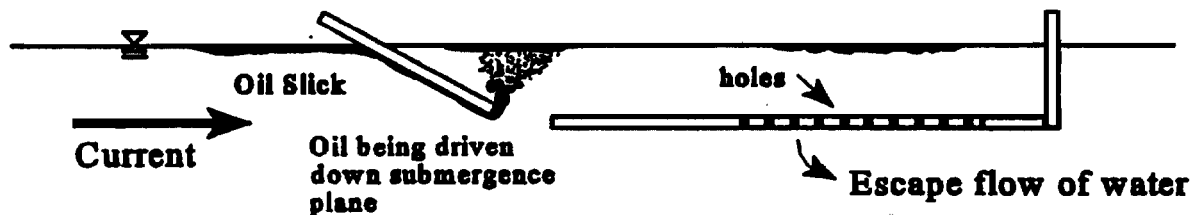
Figure 1. Cross-section schematic of the submergence plane barrier.

The submergence plane and horizontal baffle provide the functionality of the device. As shown in Figure 3 (and previously diagramed in Figure 1). The submergence plane forces the oil to submerge to the gap. Here, the oil enters through the gap and rises into the containment region. The horizontal baffle contains another strength member. Along the leading edge there is a chain that is connected at each end to an end longitudinal. This chain acts as a tension member and bears a large portion of the load when the device is deployed. Holes in the horizontal baffle also provide the exit area for the water flowing through the device.

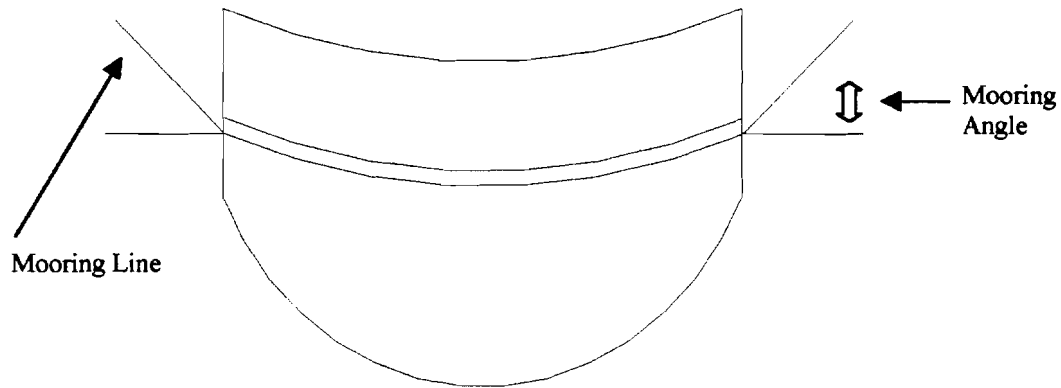
Figure 4. Mooring angle used in model tow tests.

When the device is anchored in the deployed position, the mooring line forms an angle with a line parallel to the average axis of the system (see Figure 4). This angle is referred to as the mooring angle and occurs on each side of the device. It was not known what effect, if any, an adjustment of the mooring angle would have on the desired shape of the device in the deployed position. If the mooring line continued the catenary shape formed by the leading edge of the horizontal baffle, the device would naturally assume the correct position. This ideal mooring angle was found to be 18.6 degrees, based on the catenary equations used to determine the shape of the leading edge of the horizontal

Using a one fifth scale model of the device in the UNH tow tank, Froude scaled tests were conducted to determine the effects of mooring angle on system shape retention. The mooring angles were set to values ranging from 18 degrees to 57 degrees. The device was towed at a constant speed of two knots (full-scale) for each of the angle settings. The tests showed that as the mooring angle became larger, the device began to lose the smooth catenary shape. The leading edge of the submergence plane began to crumple, and the device no longer held the ideal shape. The device did not, however, deform to the extent that there was catastrophic failure. The device retained acceptable shape between the angles of 18 and 50 degrees. The tests showed that mooring angles, while they affected the shape of the device, did not lead to catastrophic failure and that a large region of acceptable angles existed.

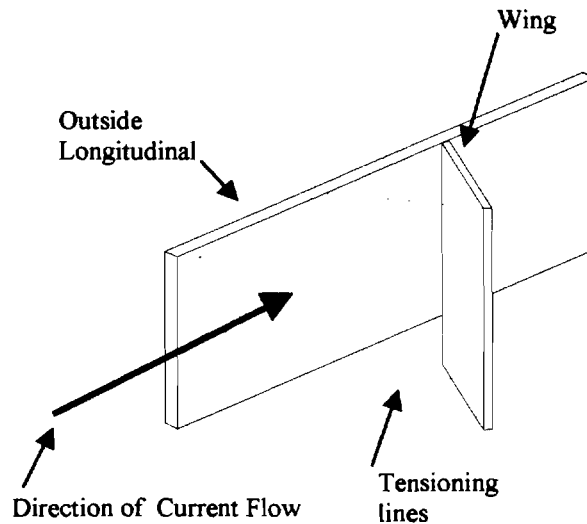
Figure 5 Drawing of wing attached to an end longitudinal to provide dynamic tensioning.

proper shape and tension on the device. The idea proposed was to use a vertical wing extending from each end longitudinal, as shown in Figure 5, to catch the oncoming water and force the device to open into the proper shape.

The proposed wings were attached to the end longitudinals of the model, and several tests were conducted. The model was towed at speeds ranging from 1 to 2.5 knots (full-scale). In addition to tests with ideal mooring angles several tests were run with different mooring angles to see if the wings would improve the shape retention at higher angles. The tests showed that the wings tested lacked the ability to create enough fluid dynamic force to make any significant difference in the shape of the device.

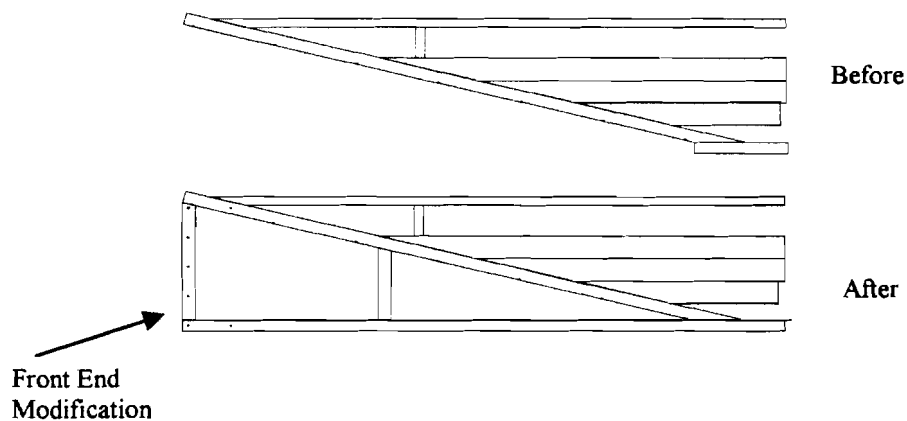
Figure 6 Front of outside longitudinal with and without the attachment.

One possible deployment configuration involved attaching conventional boom directly to the device making a continuous hybrid system. The front edges of the end longitudinals were identified as the obvious choice of attachment points. The 1997 prototype end longitudinals did not support this type of attachment since the front was angled as shown in Figure 6. The new design would square off the front end providing a vertical member that was suited for attachment to conventional boom. The 1997 prototype was modified, and an attachment points provided.

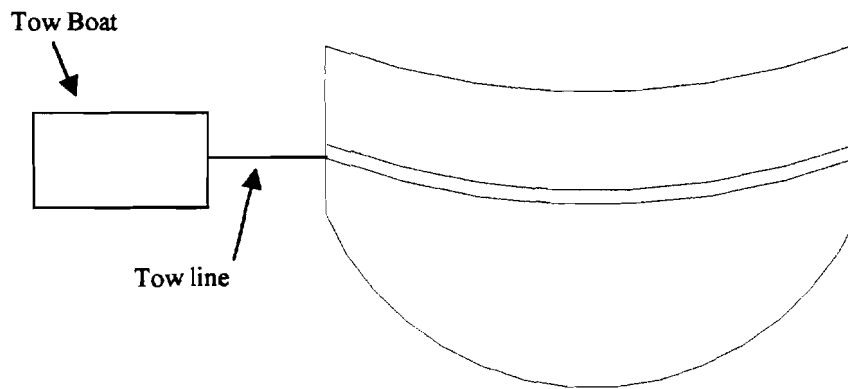
Figure 7 End tow configuration

eye was through bolted to the steel bracket termination for the chain tension member. This was by far the strongest point in the end longitudinal and allowed the system to be towed endwise as shown in Figure 7.

Problems with towing the device became immediately evident when the lead end longitudinal submerged as the towboat began to accelerate. The device was towed to the deployment position with nearly 1/3 of its full length submerged. The second boat then attached the opposite mooring line and brought the device perpendicular to the oncoming current. The first anchor was released, and after the device was put in tension by the opposite mooring line, the second anchor was released. After the second anchor settled the device was fully deployed. It held shape well and appeared to be adequately tensioned. While in this position, it collected seaweed and other debris that strayed into its path. This was very encouraging and indicated that functionality in the deployed state had not been sacrificed. Though there were several evident design changes needed, the

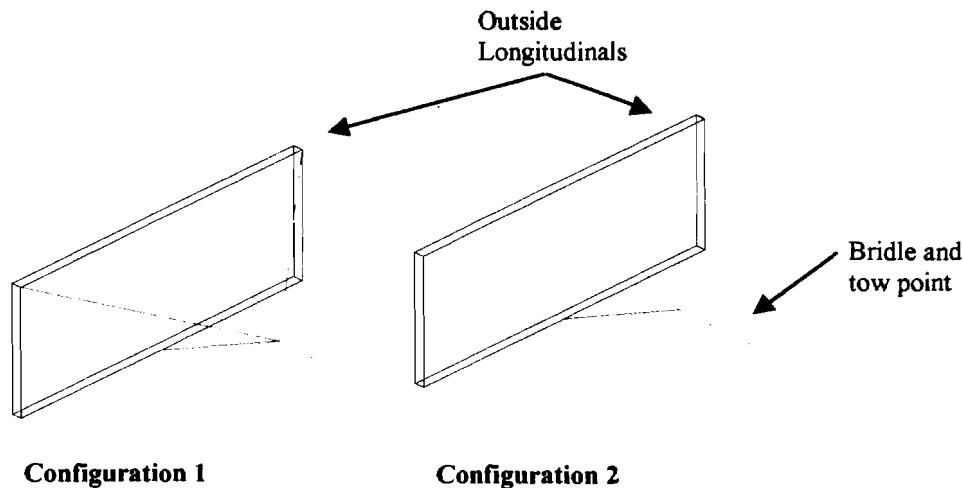
Figure 8 The two different bridle configurations used during the model tests.

The testing of the bridle proposal was conducted first. Two separate bridle configurations were used as shown in Figure 8. The model was towed at speeds ranging from one to three knots (full-scale). It was connected to the tow carriage in the same manner as in the previous emulation tests.

The results of these tests showed that the device could be forced to stay on the surface by means of a bridle attachment. Both configurations showed very similar results. When the model was towed at two knots (full-scale), there was significant water flow over the longitudinal. At three knots there was more overflow of the longitudinal, and there was significant bending in upper support. The upper support was not designed as a load bearing member, and bending was undesirable.

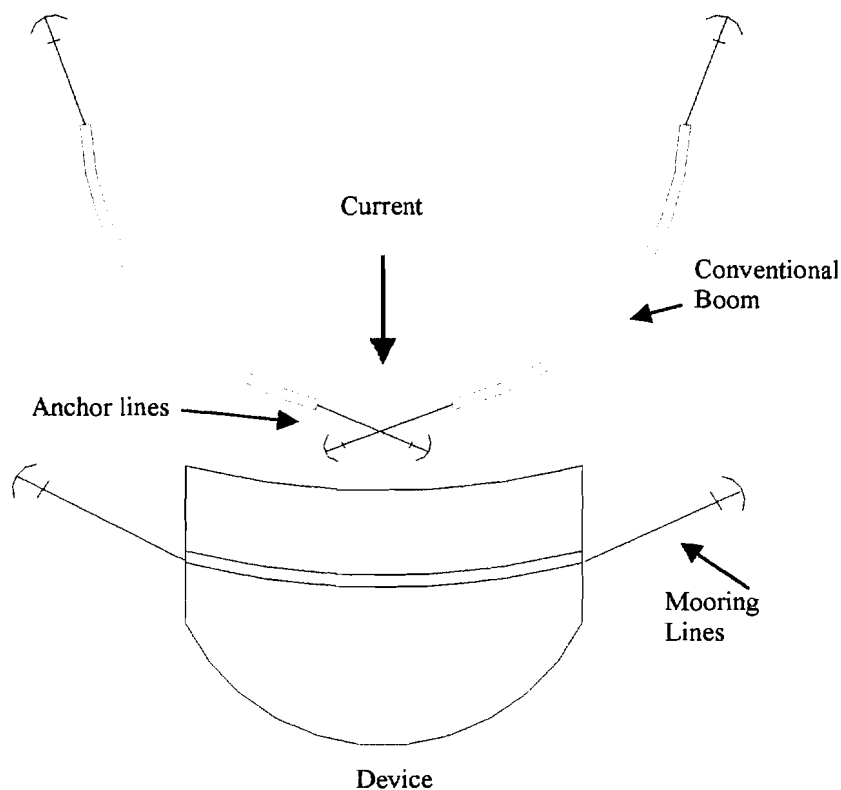
Figure 9 The proposed deployment configuration for the 2nd exercise

Prior to the exercise a meeting to formulate a plan was held between the UNH team and Steve Root. The plan of attack was to deploy a pair of 100 foot, six inch draft conventional boom segments in a catenary shape with the apex of the catenary left open as shown in Figure 9. The Bay Defender would then be positioned at the apex perpendicular to the on-coming current.

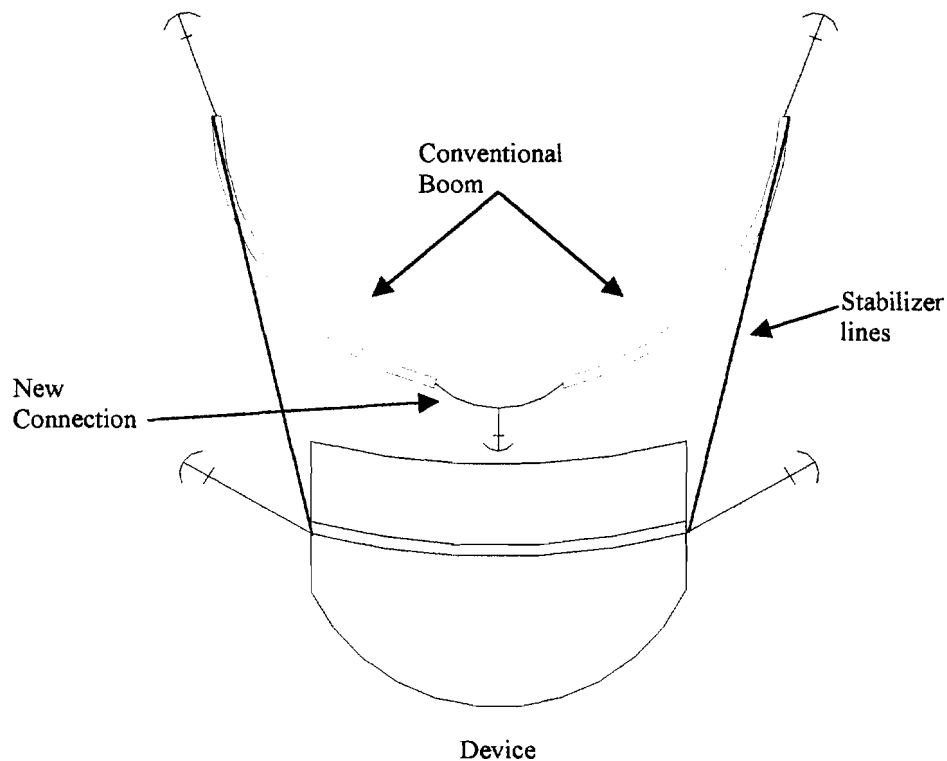
Figure 10 Improved deployment configuration for the 3rd exercise.

Another meeting was held, and deployment strategies were again discussed. Two modifications were suggested. The first was to deploy the conventional boom as a single unit by connecting the apex with a line and a single anchor. The second was to run lines from the lead edge of the conventional boom to the tow points on the device to hold it in position. The theory was that the new stabilizer lines would prevent the device from drifting and the side mooring lines could be used primarily for tensioning as shown in Figure 10.

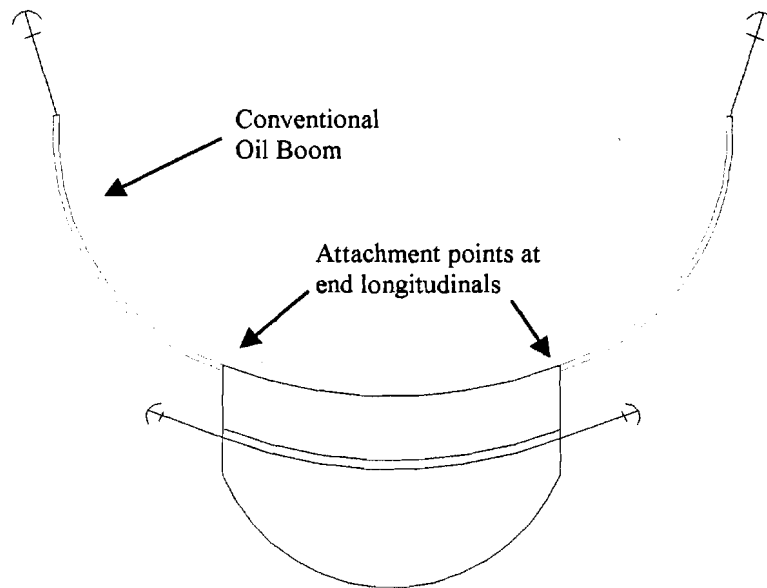
Figure 11 Physical attachment of conventional boom with the device.

The course of action chosen was one that had been anticipated from the beginning of the project. The conventional boom would be attached to the front of each end longitudinal as shown on Figure 11. This measure had not been taken before because it was feared that there might be some catastrophic failure of the end longitudinals or the submergence plane due to the forces applied when the 100-ft sections were attached.

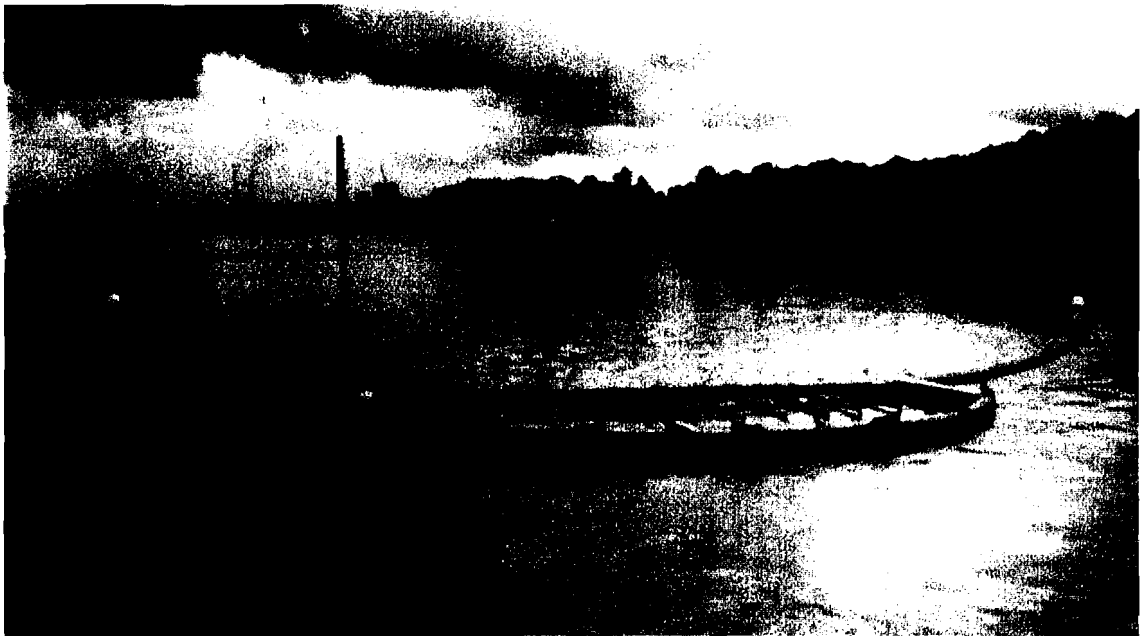
Figure 13 Fully deployed Bay Defender with conventional boom integrated.

deployment position, where the Responder retrieved and set one of the 100ft sections of boom. With the Whaler still holding the device with the towline, the Responder retrieved the second length of boom and brought the device perpendicular to the current and set the anchor. As the device was being brought around the Whaler slacked off the towline until the full drag force on the device was being held by the conventional boom lengths. The tension that the J'ing of the booms applied to the device proved sufficient enough to open it to the deployed position. The device was essentially deployed without the use of the side mooring lines. The side mooring lines were then set to provide more tensioning bringing the device to a near perfect position for oil containment. Figure 13 shows the device in its fully deployed position with the conventional boom incorporated.

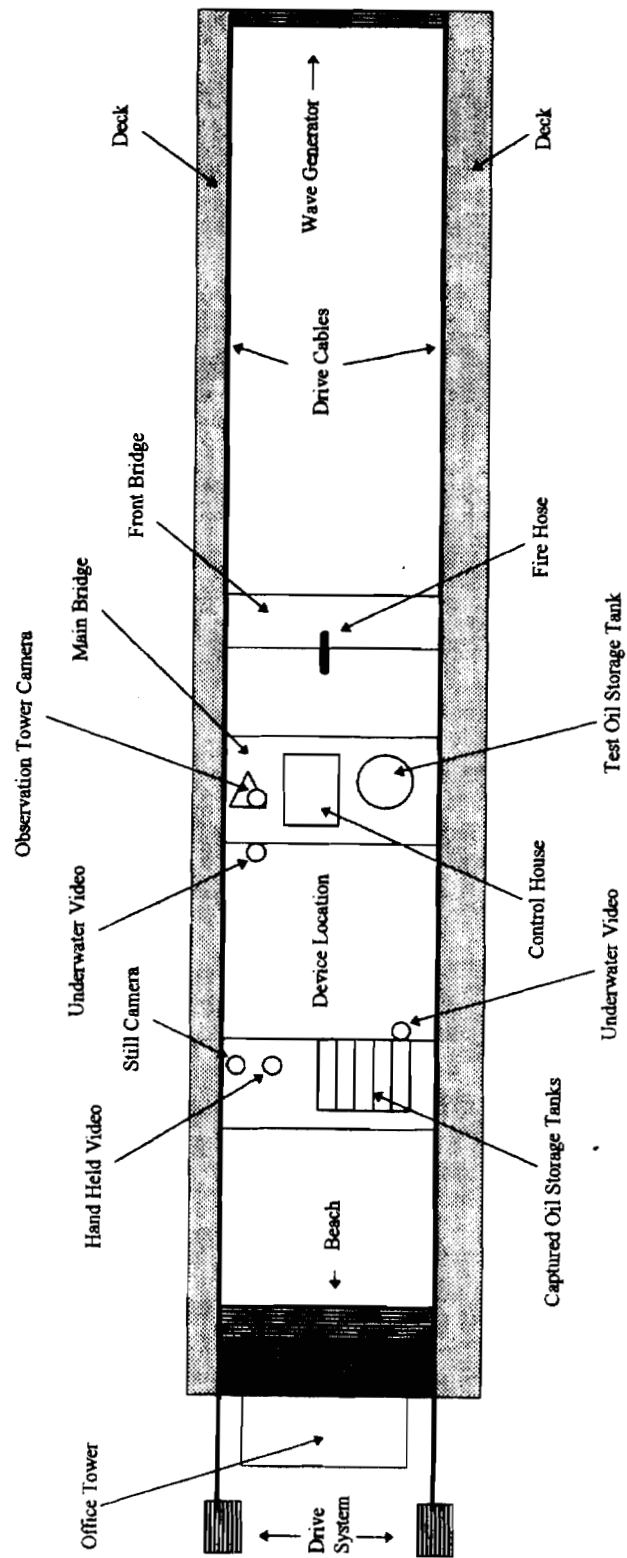
Figure 14 Ohmsett configuration, not to scale (Steen, 1997).

The Ohmsett tow tank is operated by the Minerals Management Service (MMS) through a contract with MAR Inc.. The tank is located on the northern coast of New Jersey and is an outdoor facility. Figure 14 shows a planform diagram of the Ohmsett facility (Steen, 1997). The tank is 666 feet long, 65 feet wide, 11 feet deep and holds 9.84 million gallons of brackish water. The facility is equipped to handle actual oil studies and is utilized by many commercial oil barrier manufacturers for prototype testing. There are three narrow tow carriages, referred to as bridges, positioned along the

length of the tank. They are connected to a cable drive system that runs along both sides of the tank. Each bridge can be independently positioned. The cable drive system is capable of tow speeds ranging between zero and six and a half knots. The tank is also equipped with wave making capabilities. Measurement of oil recovered is conducted using recovery tanks and chemical analysis. The oil contained within the device at the conclusion of a run is pumped into a recovery tank where it is allowed to sit. Once the majority of water has separated from the oil, it is decanted off the bottom of the tank. A sample of the oil is taken for chemical analysis to determine the percentage of water and other material still present in the recovered oil. Using this analysis, the amount of oil recovered is determined. Once the amount of oil recovered is known, it is recorded as a retention percentage by dividing by the amount of oil introduced during the run and multiplying by 100 (Steen, 1997; Swift et al., 1998). Properties of the two oils commonly used in testing at Ohmsett, are given in Table 2.

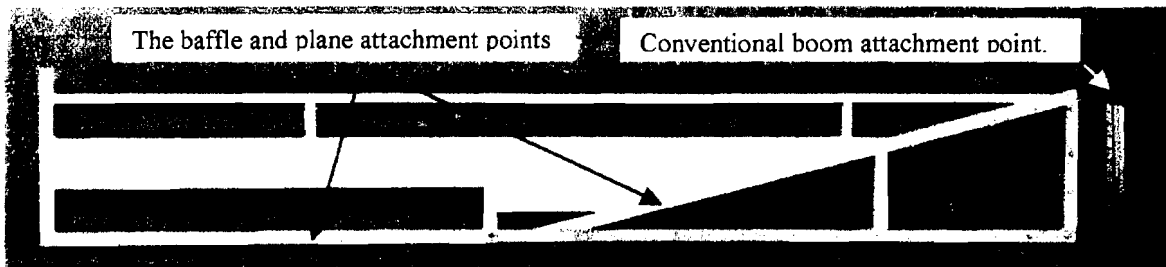
Figure 16 A completed end longitudinal. The longitudinal's frames were built by Custom Welding and Fabrication located in Northwood, NH.

The primary difference between the new and old end longitudinals (besides the material) is the attachment points for the submergence plane and the horizontal baffle. Aluminum angle stock welded to the side of the longitudinal serve as the attachment point base. This removes the need for the longitudinal to be picked up for attachment of the fabric. The bolts used to attach the components are left in place and do not have to be removed during attachment. This saves time and prevents the bolts from being dropped in the mud and becoming difficult to handle. Figure 16 shows the end longitudinal. See the Appendix for technical drawings.

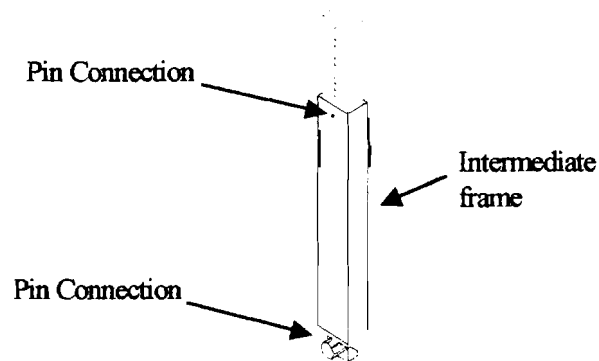
Figure 17 AutoCAD rendition of the telescoping tube/pin arrangement.

The adjustability of the bite (vertical distance from the rear edge of the submergence plane to the leading edge of the baffle) was incorporated into the intermediates. A telescoping tube/pin arrangement, as shown in Figure 17, allows for the leading edge of the horizontal baffle to be lowered increasing the bite.

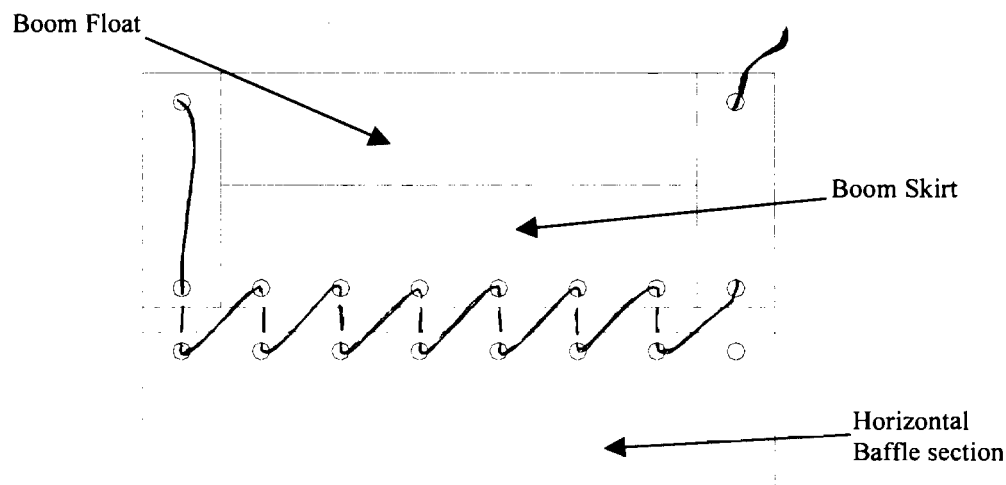
Figure 19 Section of boom showing the rope lacing used to adjust the apex.

The existing rear boom was modified to accommodate the deeper draft by adding three inches to the skirt length. The adjustability of the apex exit area was designed into the rear boom. An adjustable rope-lacing configuration was used as shown in Figure 19. The rope can be loosened at the top of the boom and the apex will open according to how much slack is permitted in the line. The boom can also be fixed in place using standard steel quicklinks, which are used in the non-adjustable portion of the boom. The quicklinks were used to replace the zip ties in the previous design.
